1903 North Eastern Railway Electric Autocar Trust

Newsletter No.32 — Summer 2017

# Progress Report

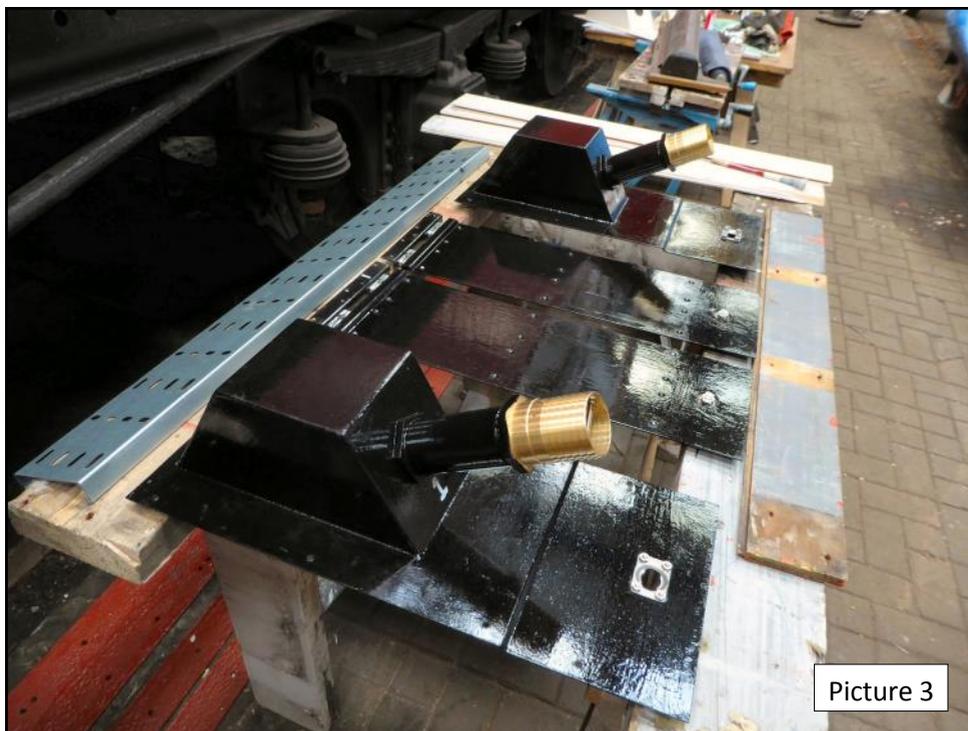
Picture 3

Alan, Dave Moore and I spent a lot of time on the detailed design, and Geoff and Alan searched for a suitable local supplier who could make the recessed steel boxes to be inset into the bodyside. The pictures show the end result much better than I can describe in words. Picture 2 (previous page) shows the alterations to the body framework that Alan made to accommodate the steel inserts, which are shown after painting but before fitting in Picture 3. Picture 4 opposite top shows the final assembly before refitting the floorboards (notice the red circular fuel gauge towards the bottom left of the picture) and picture 5 opposite below is an ‘ant’s view’ showing how tight the clearance is. Picture 6 (page 10) shows Alan refitting the floorboards.

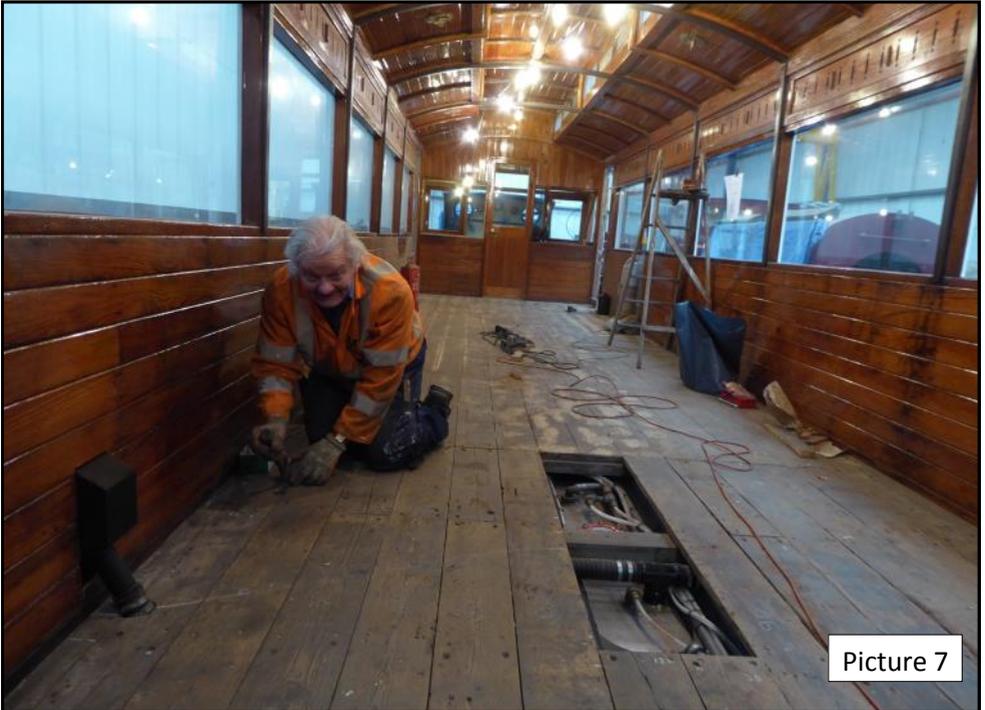
patches filled and then sanded to give a level surface, particularly in the centre walkway which will get heavier use and therefore wear more quickly if the base is uneven. Alan and Dave spent a long time on this, and it needs patience as the filler takes several days to dry (during which time anyone who accidentally treads on it is not very popular!). Picture 7 opposite top shows Dave preparing the floor for the lino.

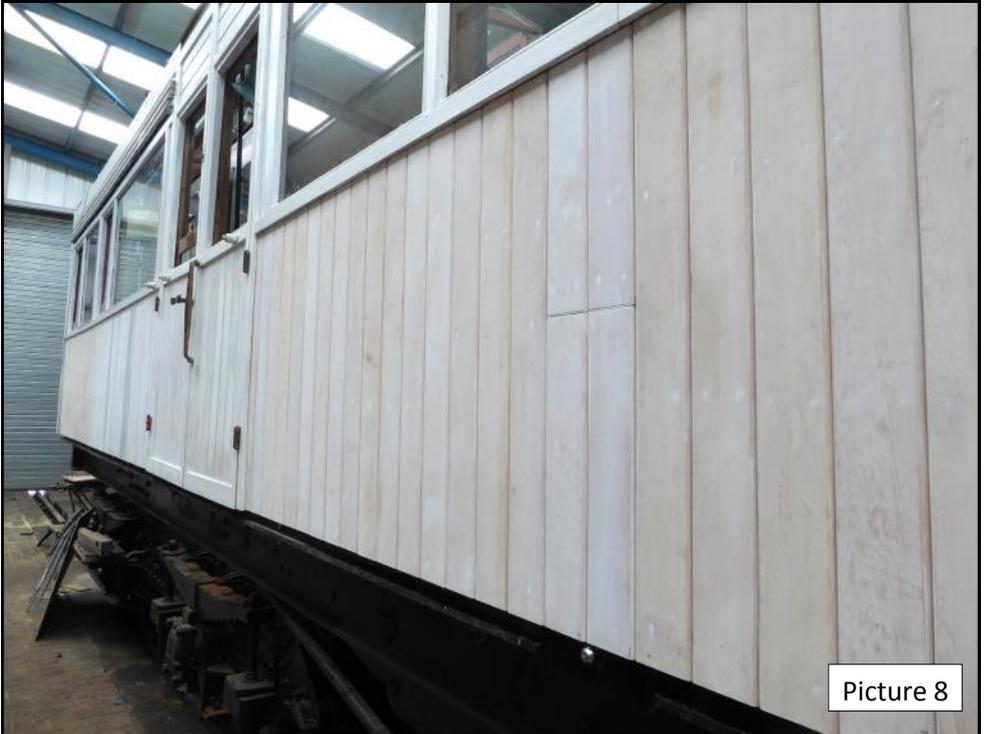
Picture 8

Now the fuel fillers are fitted the last of the external tongue & groove panelling on the sides has been fitted — see picture 8 opposite bottom — leaving only the engine end which needs major work to rebuild the framing first — see picture 10 (page 13). Geoff has made a start on this. All the doors and droplights have been panelled and hung by Colin, who has also refitted the door droplights and made them work so both sides and one end are now virtually ready for painting. This might sound like ‘jumping the gun’ a bit when the roof above the engine has not yet been fitted, but the painting and lettering has to be done in warm weather and we have a volunteer for this who will be ready to start at the end of July.

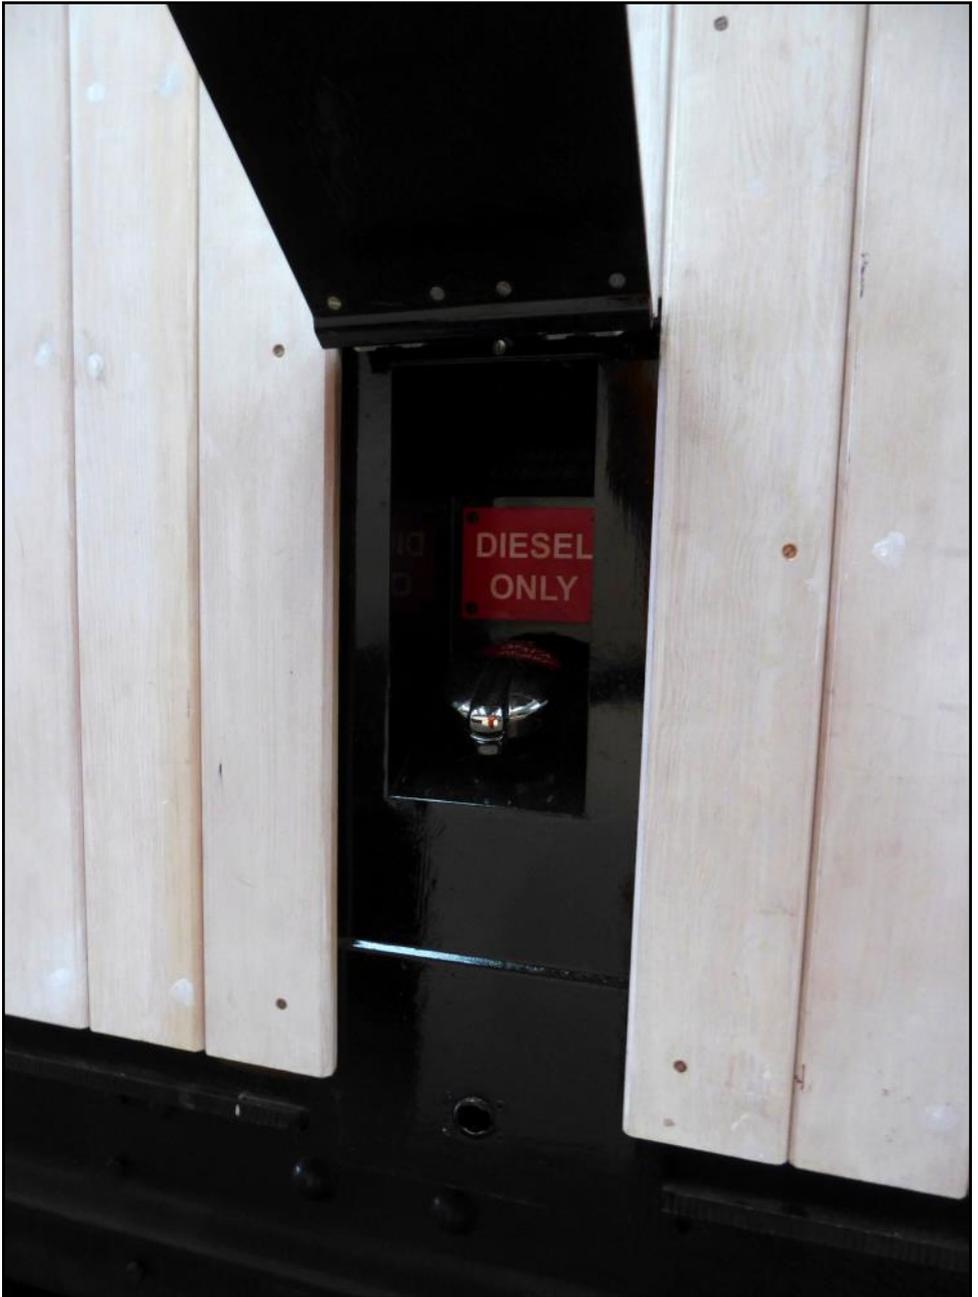
The external view of a fuel filler.
