1903 North Eastern Railway Electric Autocar Trust

Newsletter No.31 — Spring 2017

# Engineering Progress Report

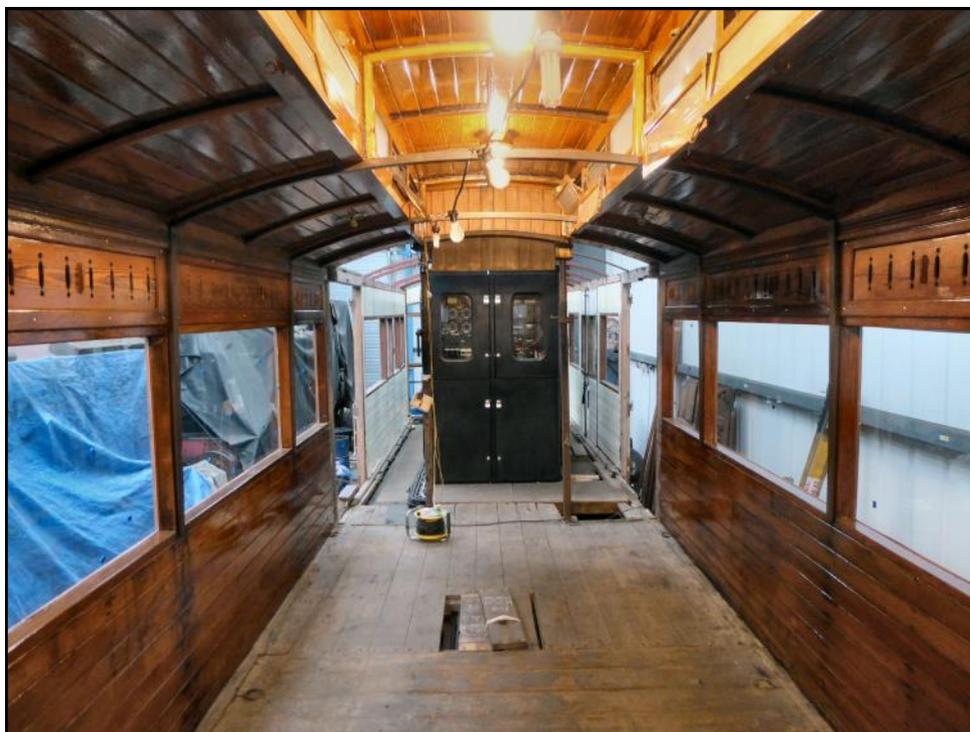
**Below:** *The view from the saloon into the engine room, with the partition removed to allow work under the floor. (Alan Chandler)*

I mentioned last time that we found that that the floor bearer under the engine end partition was broken when the body was lifted over. Since this bearer supports the sliding door between saloon and luggage area, and a level base is essential to make the door slide smoothly, we decided to replace this bearer before proceeding further. This meant supporting the end of the steel roof assembly of the engine compartment with Acrow props before removing the partition and then the end section of the flooring. Having done this, we discovered that the tenon on the next floor bearer in the saloon was broken at one end, and a third bearer had no tenon at either end, so it was effectively floating. Geoff therefore fitted steel corner brackets to both these and the new bearer which Alan had made and fitted, to secure them before replacing the floorboards. As far as we can see, the remaining floor bearers are OK.

These cross-members join the walls together at floor level and support the floorboards. To gain access to the first cross-member it was necessary to remove the partition and lift the floorboards at the engine end of the passenger compartment (*as per the photos on pages seven and nine*).

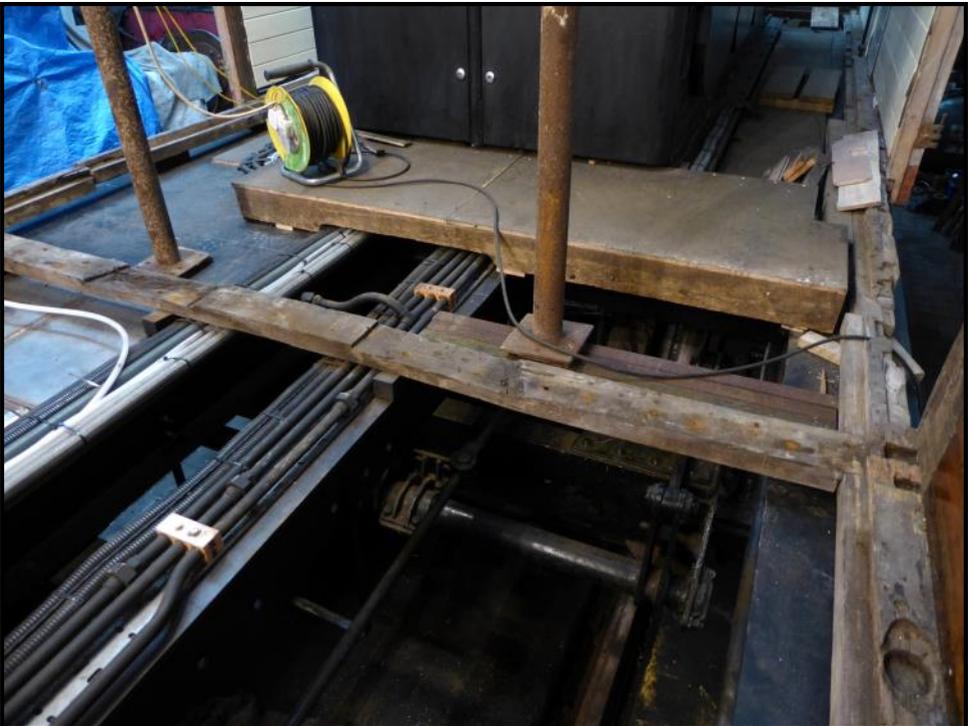
**Below:** *A close-up of the partition old cross-member, showing its condition.*

When the body was lifted on to the underframe, back in July 2016, it was found that the cross-member under the partition was broken in the centre and would therefore need to be replaced. It was then discovered that another cross member had broken tenons, and a third was loose, without any joint or fixing to the timber frame at the base of the walls, allowing the floorboards closest to the walls to twist and split. A survey of all the remaining cross-members did not reveal any further problems.

The partition cross-member has now been replaced with a substantial beam of hardwood, jointed and bracketed to the wall bottom rails (*as in the photo below*). The cross members with broken or missing joints have been securely fixed to the bottom rails with strong brackets. New door sills and new pipework for an emergency brake application from the passenger compartment can also be seen. Work has now started on replacing the partition and passenger compartment floor.

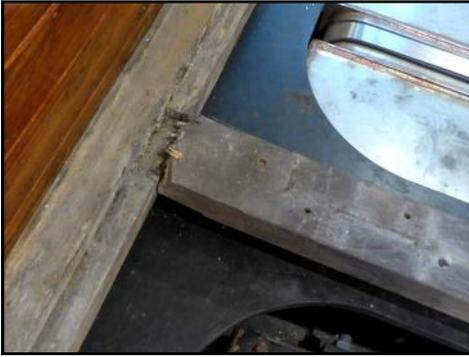
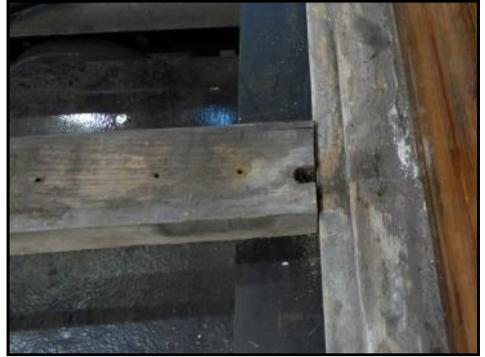
The other two cross-members, with broken and loose tenons.

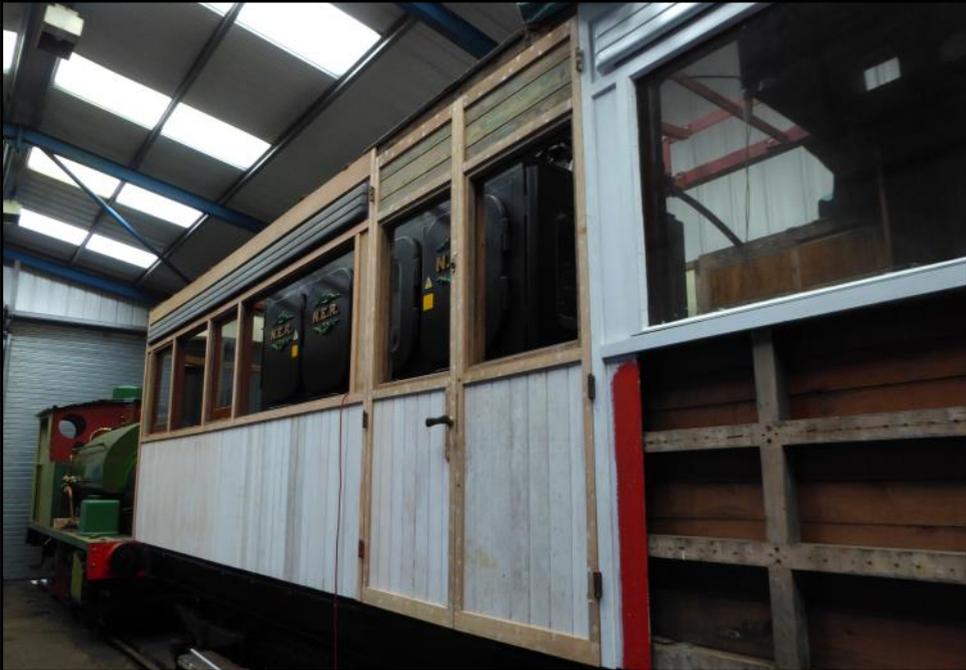
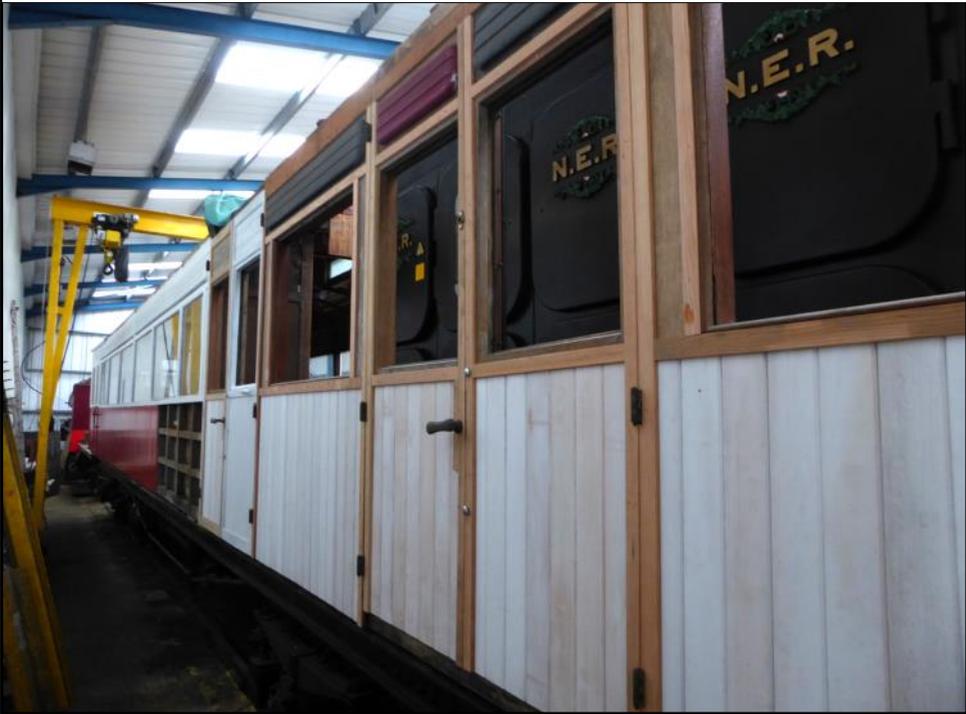
Above and below: Tongue and groove replacement body-side panels.
