1903 North Eastern Railway Electric Autocar Trust

Newsletter No.32 — Summer 2017

# Progress Report

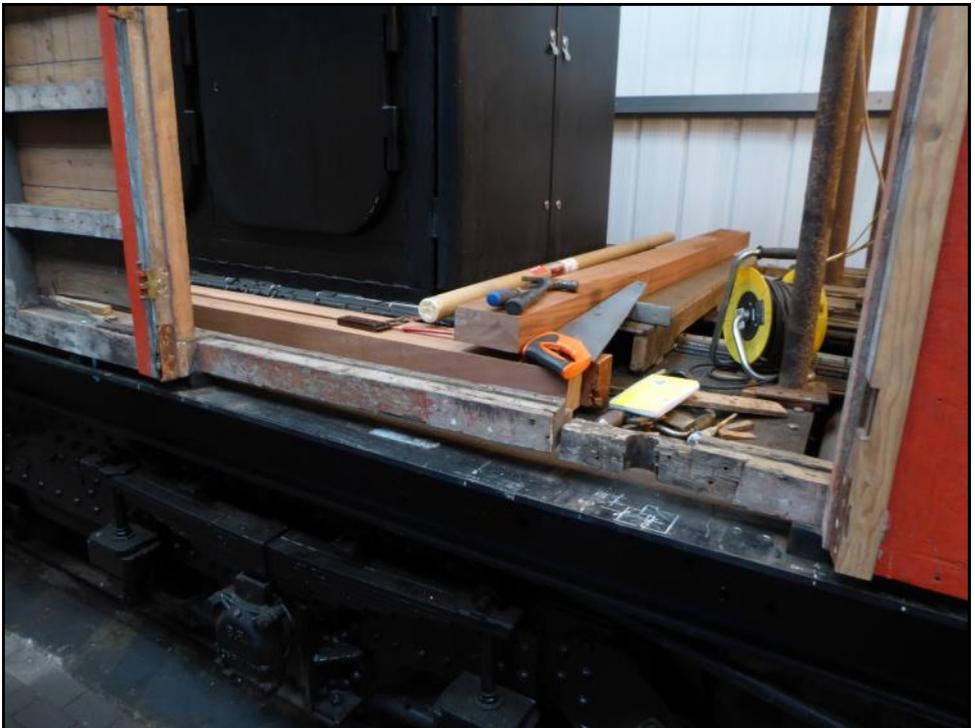
One of our concerns in designing the underframe was the likelihood of theft of 'valuable' items such as copper and diesel fuel, since several heritage railways

have suffered from this. We wanted to make it less obvious to the casual observer that this was a powered vehicle (and hence have fuel tanks), so the tanks are mounted high up in the underframe, where they are less visible. At an early stage we had talked to several of the railways who might be interested in operating the autocar as to whether they preferred a diesel loco type filler with a screwed connection or a DMU type, which is like a lorry or car but slightly bigger. The result was to go for a DMU type. As this depends on a gravity feed, our original intention was to have the filler point inside the luggage compartment adjacent to the engine, with the pipe to the tank going under the partition and into the top of the tank, which is about one quarter along the length of the saloon. However, it proved impossible to fit this pipe in the space available under the saloon partition because of the number of air pipes and electrical conduits in this area (all of which also have to go under the floor bearers), so we decided to fit a concealed filler each side of the vehicle in the bodyside, and run the 2" pipe to the tank top down to floor level and then under the floorboards to a tee piece screwed into the top of the tank.

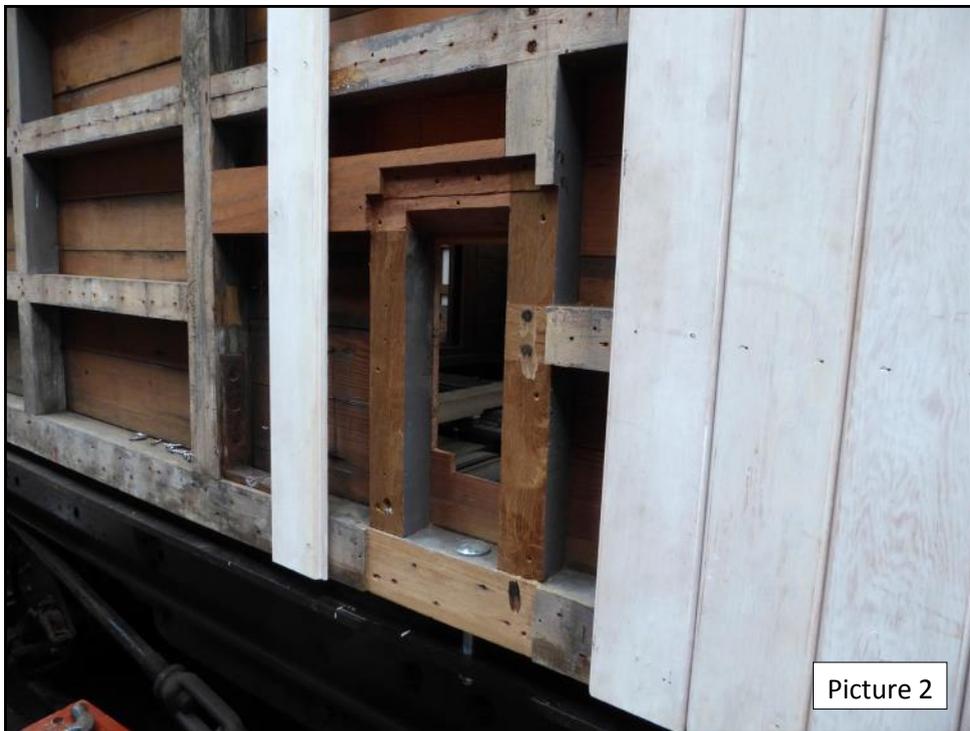
Alan, Dave Moore and I spent a lot of time on the detailed design, and Geoff and Alan searched for a suitable local supplier who could make the recessed steel boxes to be inset into the bodyside. The pictures show the end result much better than I can describe in words. Picture 2 (previous page) shows the alterations to the body framework that Alan made to accommodate the steel inserts, which are shown after painting but before fitting in Picture 3. Picture 4 opposite top shows the final assembly before refitting the floorboards (notice the red circular fuel gauge towards the bottom left of the picture) and picture 5 opposite below is an ‘ant’s view’ showing how tight the clearance is. Picture 6 (page 10) shows Alan refitting the floorboards.

To enable access in the future to the pipework around the gauge if any problems arise, we are going to fit a small section of removable floor in this area which will include a viewing window to see the gauge.
